### Collision Reconstruction Report

Sara Echevarria vs. U-Haul Company

Delaware State Route 2 near the Intersection of Upper Pike  
Creek Road

Date of Accident: May 15, 2004

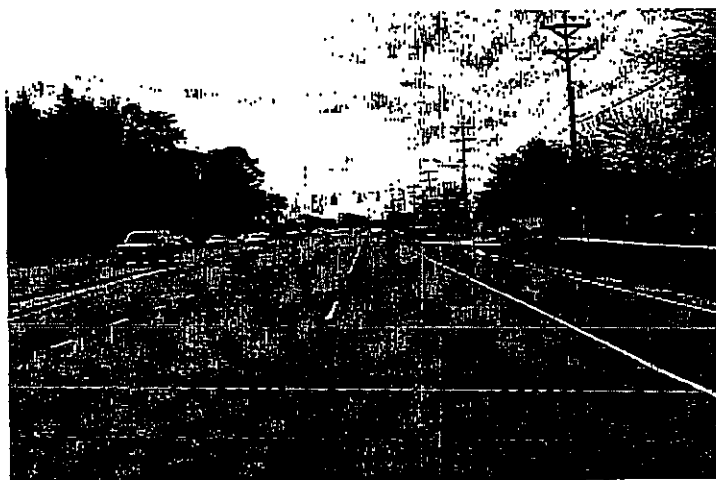
1. State Route 2, at the collision location near the intersection of Pike Creek Road, was a properly divided six-lane roadway that traveled in a west/east direction. The roadway had the proper lane delineations and transverse markings for the travel lanes as seen in photograph #1.

**Photograph #1: State Route 2 at the collision location near  
Pike Creek Road  
(Writer's Photograph)**

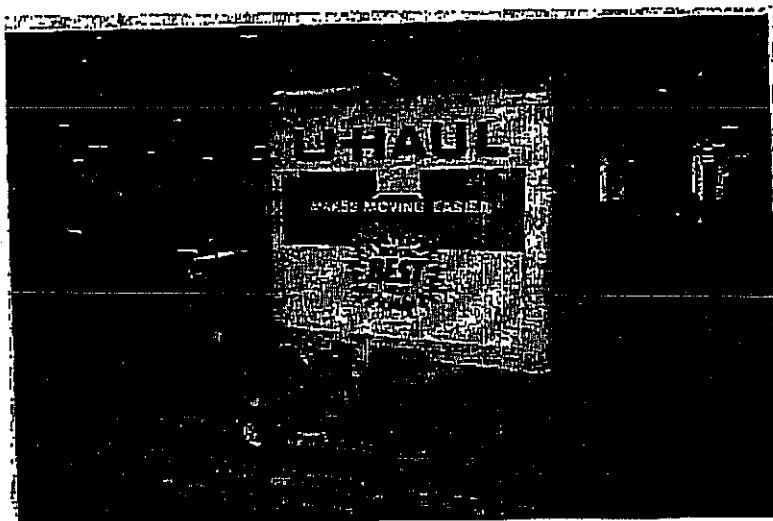
The majority of the damage to the 12-foot U-Haul trailer was located at the front tongue, which struck and penetrated the side of V<sup>1</sup> resulting in its rollover onto the roadway. The trailer's associated frontal view and tongue damage can be seen in photographs #2 and #3.

**Photograph #2: Frontal View of the 12-Foot U-Haul Trailer (Case File Photograph)**

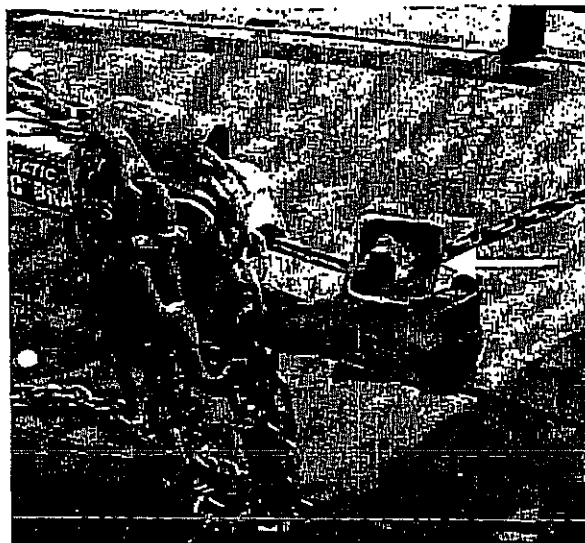
**Photograph #3: Tongue Damage to the 12-foot U-Haul Trailer (Case File Photograph)**

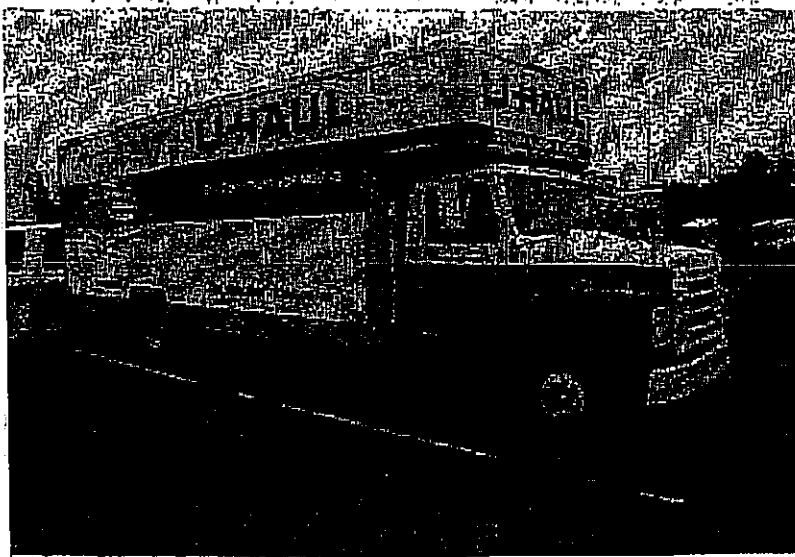
First, a frontal overview of the subject truck without any noticeable contact damage can be seen in photograph #7.

**Photograph #7: Frontal View of the 1988 International Navistar (Case File Photograph)**

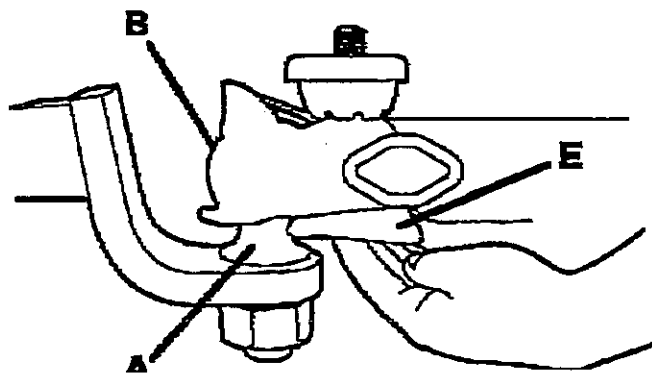
**Figure 1: U-Haul Coupler**

The tongue attachment to the hitch consisted of a latch clip and a hand wheel assembly. By turning the hand wheel assembly clockwise, it tightens the tongue to the 2-inch tow ball attached to the hitch. If the hand wheel is damaged or malfunctions, the trailer will not be properly attached and will become detached during the normal driving operation of the trailer.

During the routine six point inspection conducted by U-Haul prior to rental of this unit to Mr. Mayfield, the components of the trailer's coupler were not properly inspected nor was Mr. Mayfield given the proper instructions regarding the attachment and proper use of the trailer during his cross country towing of this trailer.

If U-Haul had completed a thorough inspection, they would have detected a problem with the trailer's hand wheel thus preventing the detachment of the trailer from the truck.
